LIMITED VISUAL WATER INTRUSION SURVEY

**SOARING EAGLE LODGE SNOWSHOE RESORT
SNOWSHOE, WEST VIRGINIA**

PSI PROJECT NO.: 0443-552

MAY 20, 2015

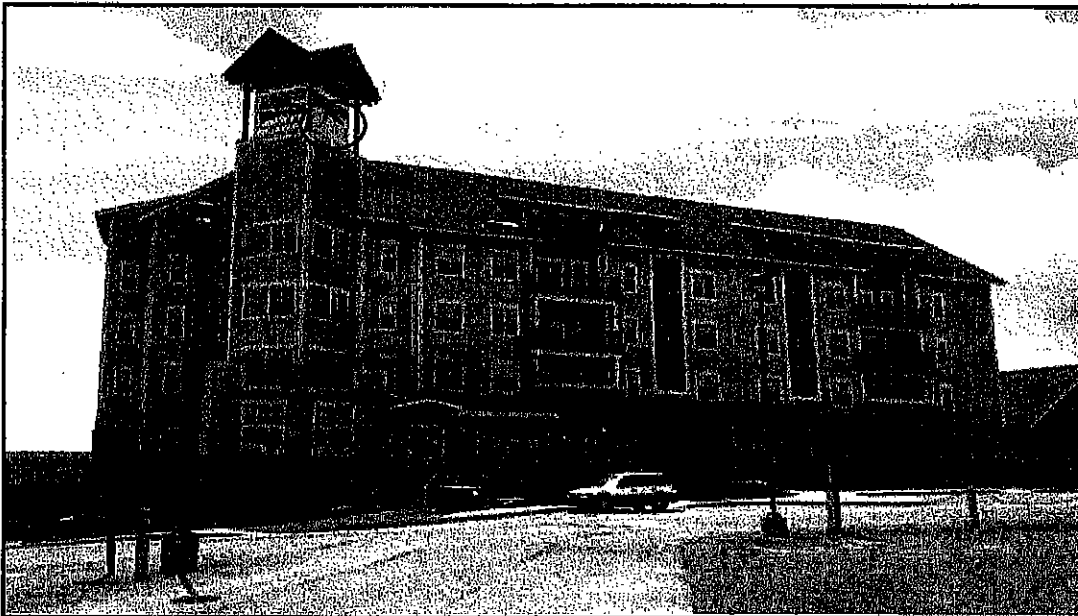
Photo No. 1

Upon arrival it was observed that large sections of shingles were missing in several areas on the roof as well as the lower section of signage on the northwest turret. Once inside the attic space the following roof make-up was observed:

- a. Architectural shingle roof system was observed with several large areas of missing shingles. This appears to be due to the high wind speeds, shingle head-lap exposure, minimal use of fasteners and the failure of the OSB sheathing to properly grasp the shingle fasteners (nails).

View of the west elevation showing several roof elevations. Note missing shingles and lower signage.

our survey indicate that the shingle roof as installed is in poor condition and replacement is required.

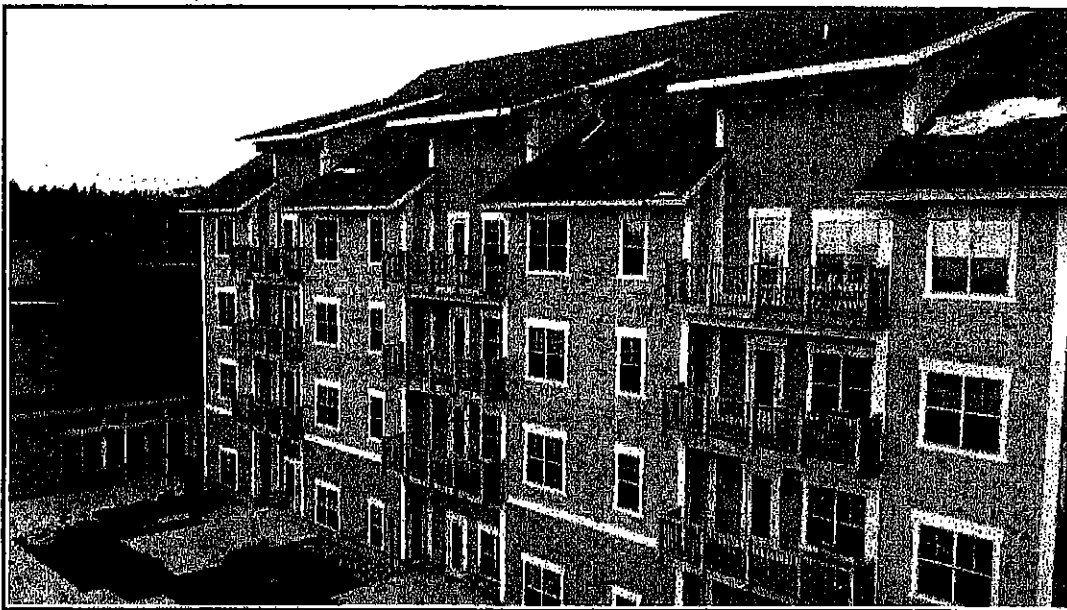
Photo No. 3

- c. Several locations have had the fascia and/or rake metal blown off due to improper fastening, the use of standard aluminum trim nails in this type of environment is not recommended. The area is subject to very high winds as well as heavy snowfall most of the year.

View of the east elevation. Note areas of missing/blown shingles and trim metal.

The fascia and rake trim metal should be replaced as needed and a more substantial and compatible fastener used to secure the existing trim metal.

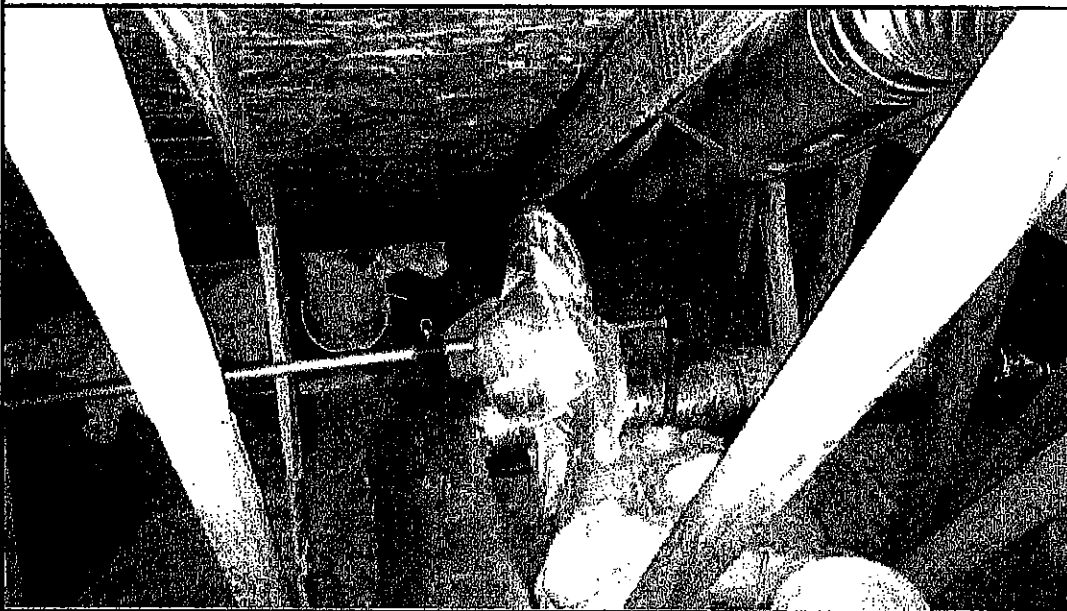
Photo No. 4

View of leak area in attic. Possibly emanating from B-Vent flashing.

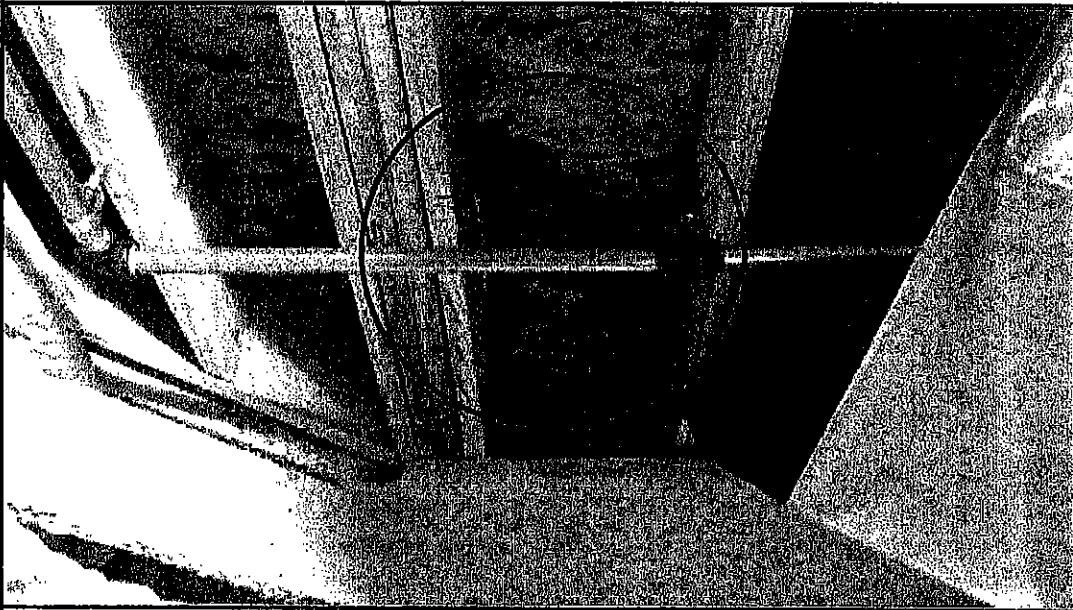
Photo No. 6

Water damaged OSB showing signs of mold in attic area.

Additionally the OSB sheathing is not a suitable substrate for this roof deck as once it is exposed to moisture it begins to delaminate and deteriorate allowing the fasteners to become loose and the decking to become spongy. PSI recommends the removal of the existing OSB roof sheathing over the entire asphalt roof area and replace with CDX Plywood sheathing.

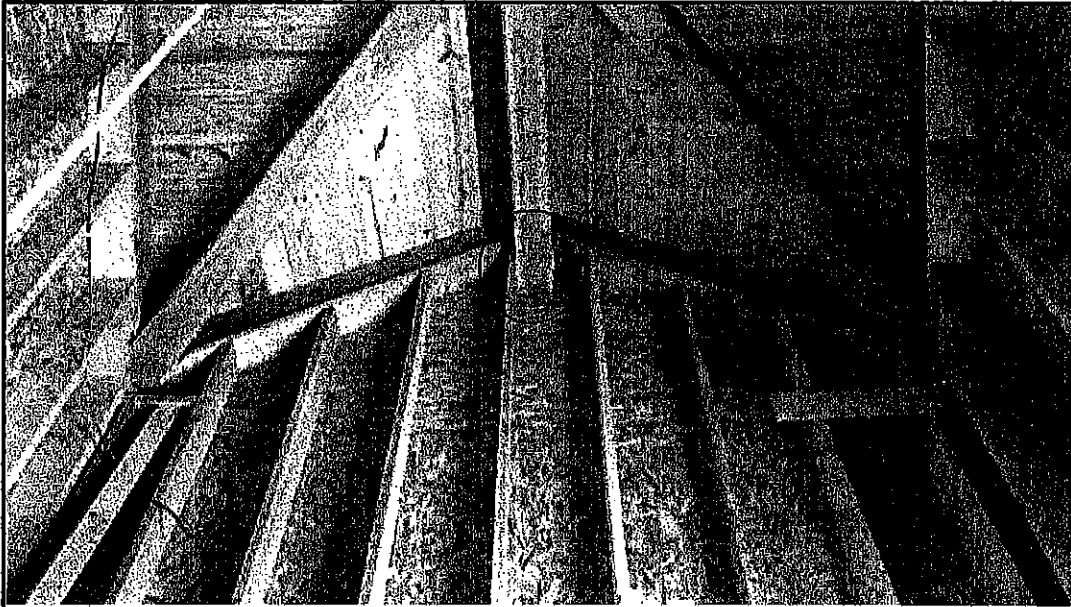
Photo No. 7
View of opening around beam pocket on the turret.

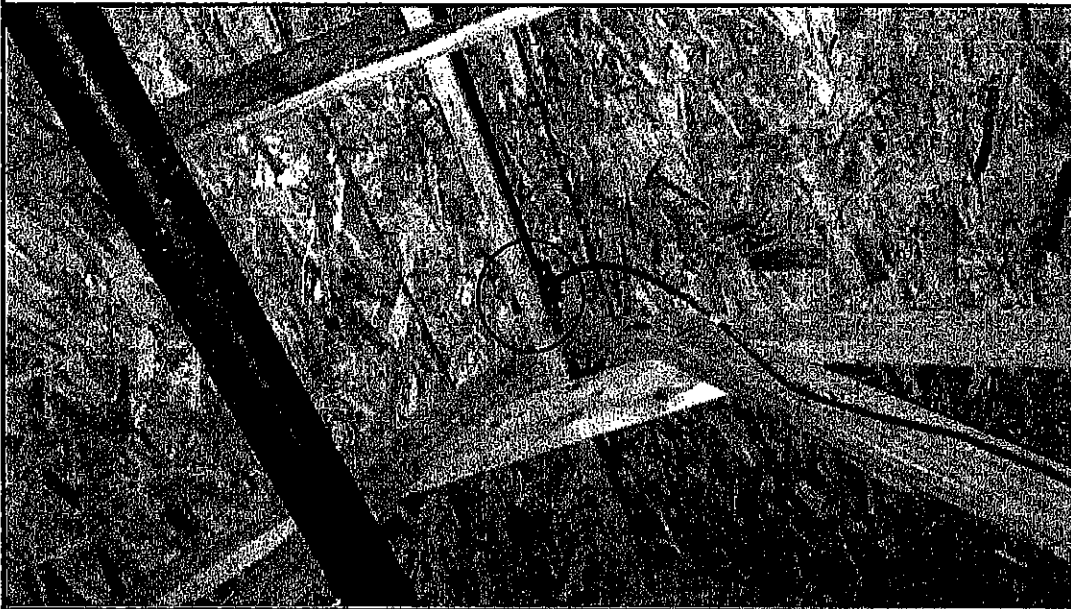
Photo No. 8
View of openings around lightning protection wiring through the roof.

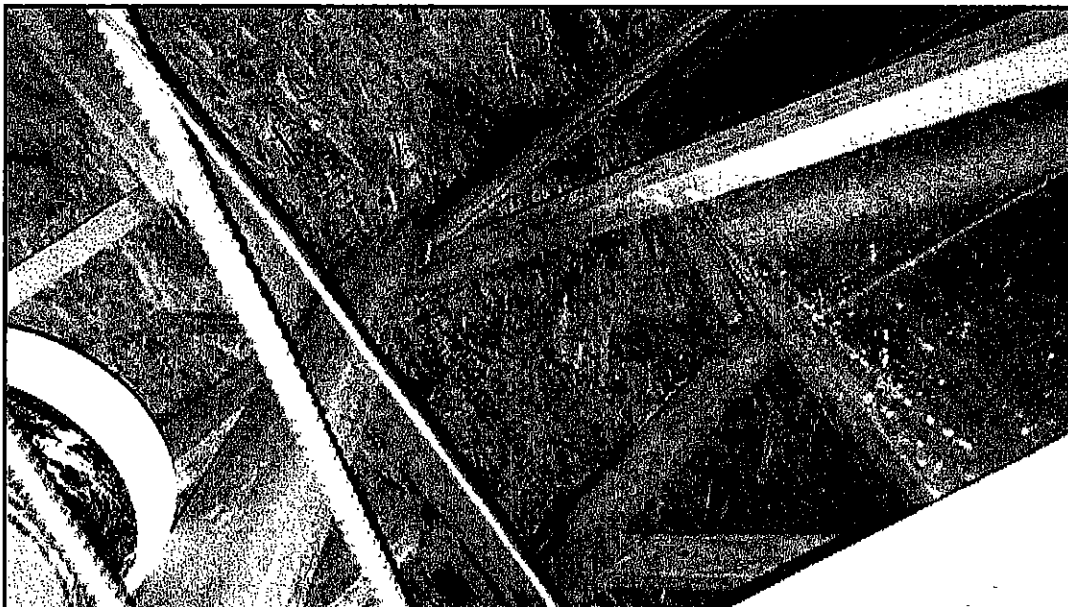
Photo No. 9

View of duct penetration through the roof. Note water marks running down the side of ductwork and damaged OSB sheathing.

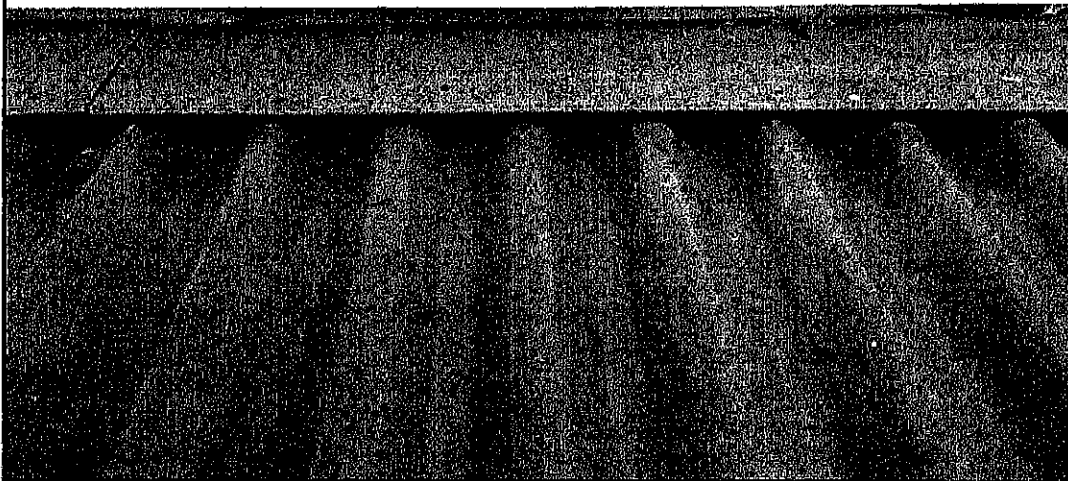
Photo No. 10

- a. The corrugated metal roofing panels are attached with neoprene grommet screws through the metal panel to the roof deck sheathing. PSI observed missing fasteners at the siding to metal roof transitions flashing allowing water to enter below the corrugated metal and eventually to the roof sheathing. PSI observed this condition has resulted in wet ceiling tiles on the inside of the restaurant at the front of the building.
- b. The method of attachment of the corrugated metal panels with through-fasteners will allow the roof to flex when loaded with snow and bypass the neoprene grommet, thereby allowing water entry into the roof framing members.

View of missing fasteners at metal roof apron flashing to wall transition.

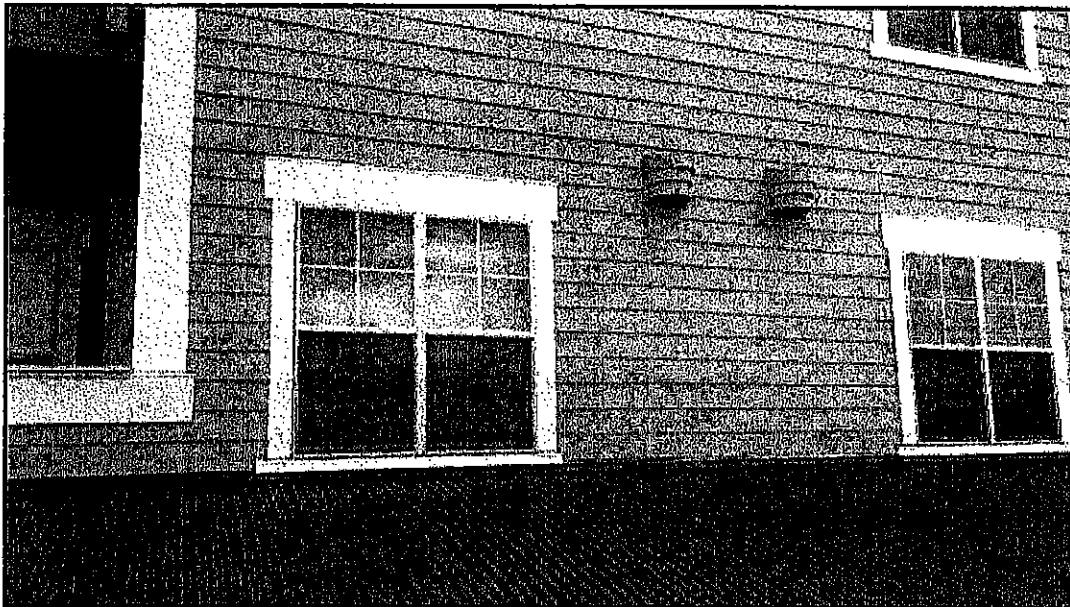
Photo No.11

Overview of corrugated metal roof to wall transition. Fasteners missing in several locations.

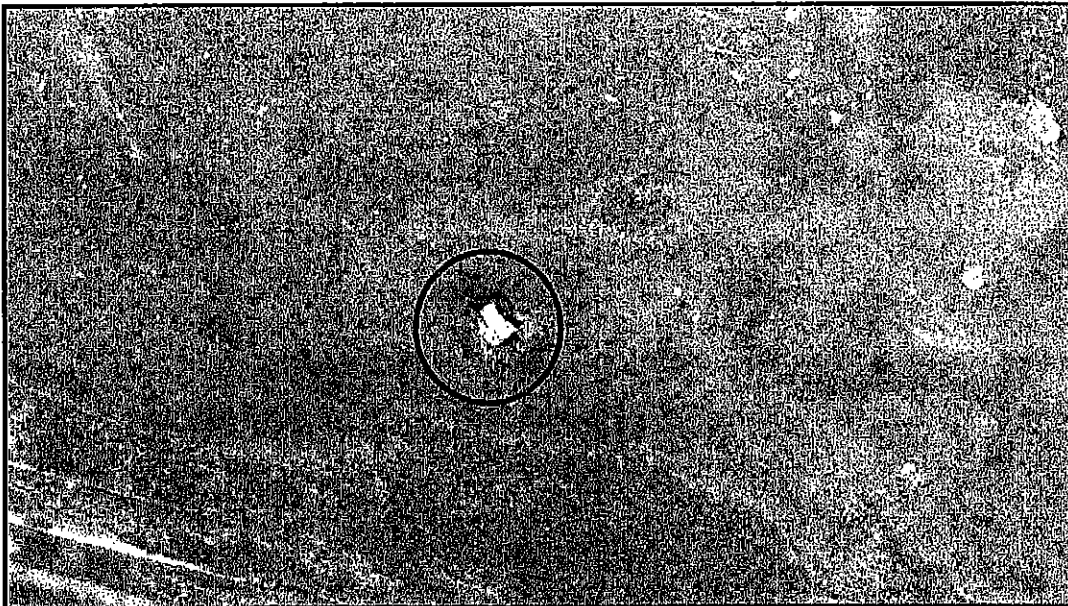
Photo No.15

- b. The roof membrane was found with multiple holes, rips and punctures in a number of areas during the survey. These appear to be caused by falling shingles, trim metal and cementitious siding as it was pulled from several of the holes.
- c. Several areas around the drains had water ponding due to debris accumulation.

View of fibered cement siding puncture in EPDM roof membrane.

EPDM Single Ply Roof Membrane - Once a roof system has been breached by moisture resulting in saturated materials, corrective action to solve the immediate problem and also reduce moisture content to acceptable levels is very limited. The configuration of the roof support structure on this roof section appears to be appropriate for the application of several types of low sloped replacement roof systems. If a roof-over type of remediation is selected, all existing "wet" roof areas should be removed and replaced. PSI recommends replacement of this roof section.

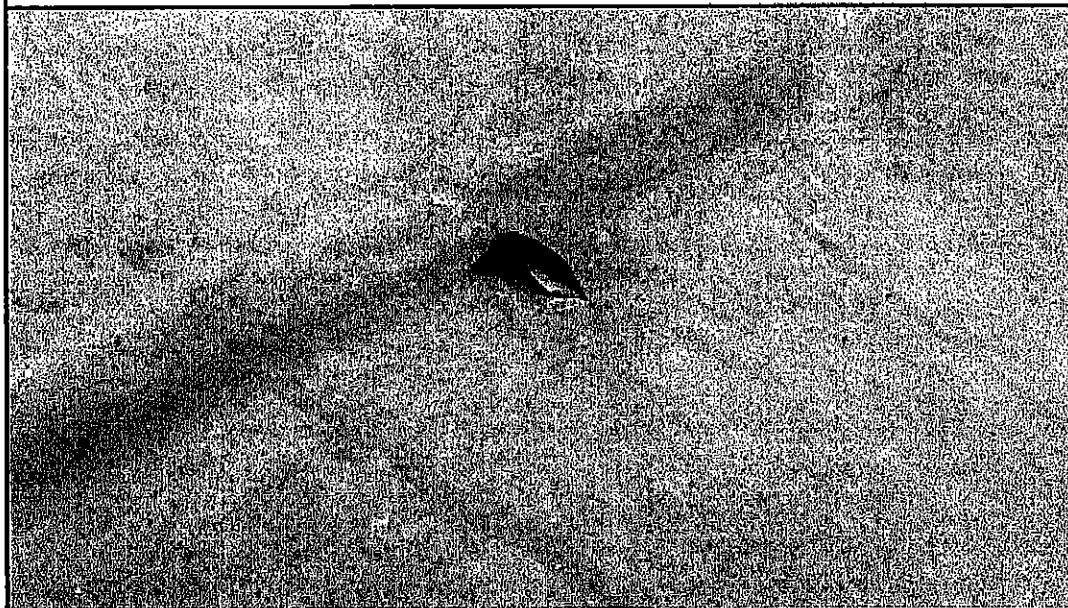
Photo No.16

View of typical puncture found in EPDM membrane showing insulation below.

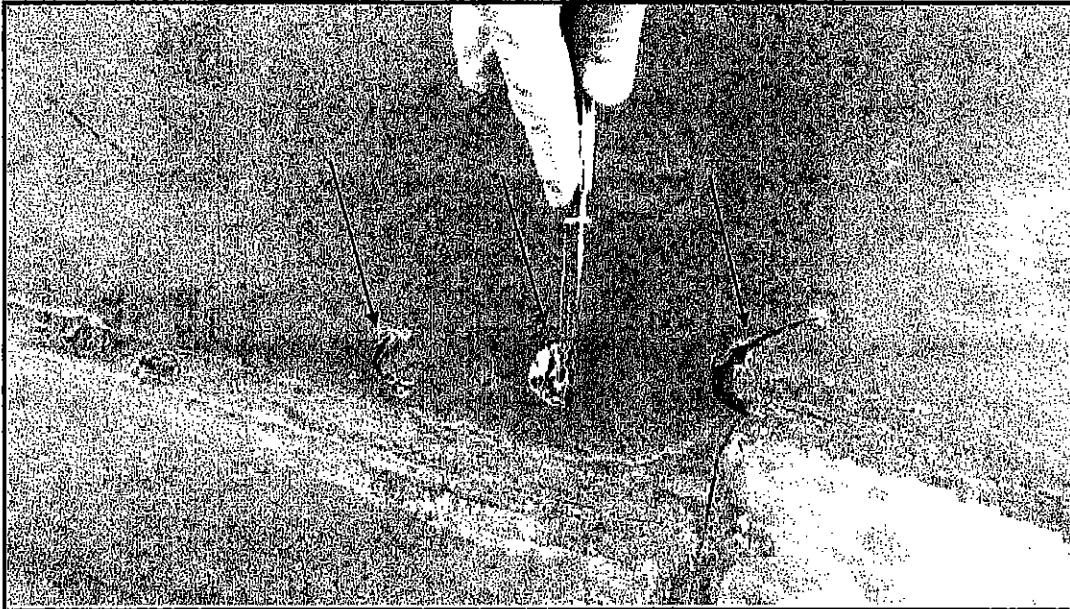
Photo No. 17

View of several tears in a row as if something was drug across the membrane.

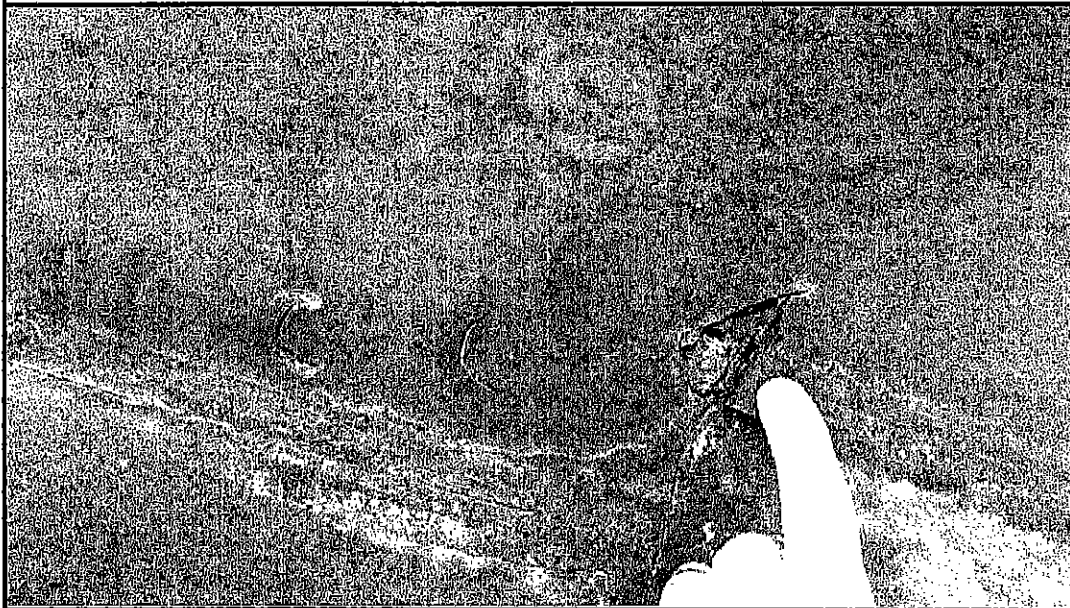
Photo No. 18

Close up view of tear showing damaged insulation below membrane.

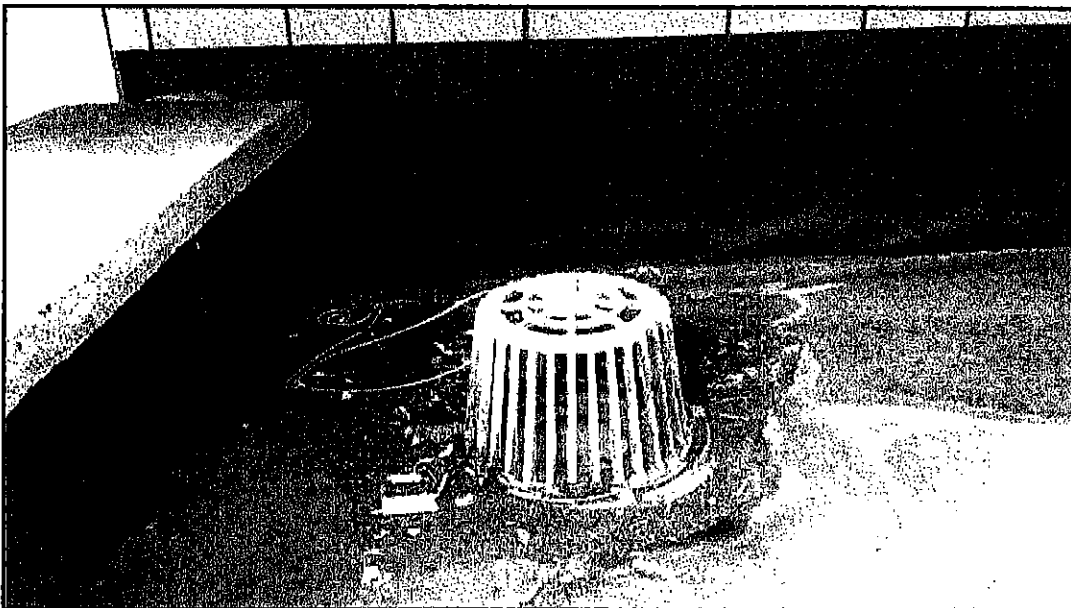
Photo No. 19

View of debris around drain bowl on the lower EPDM roof.

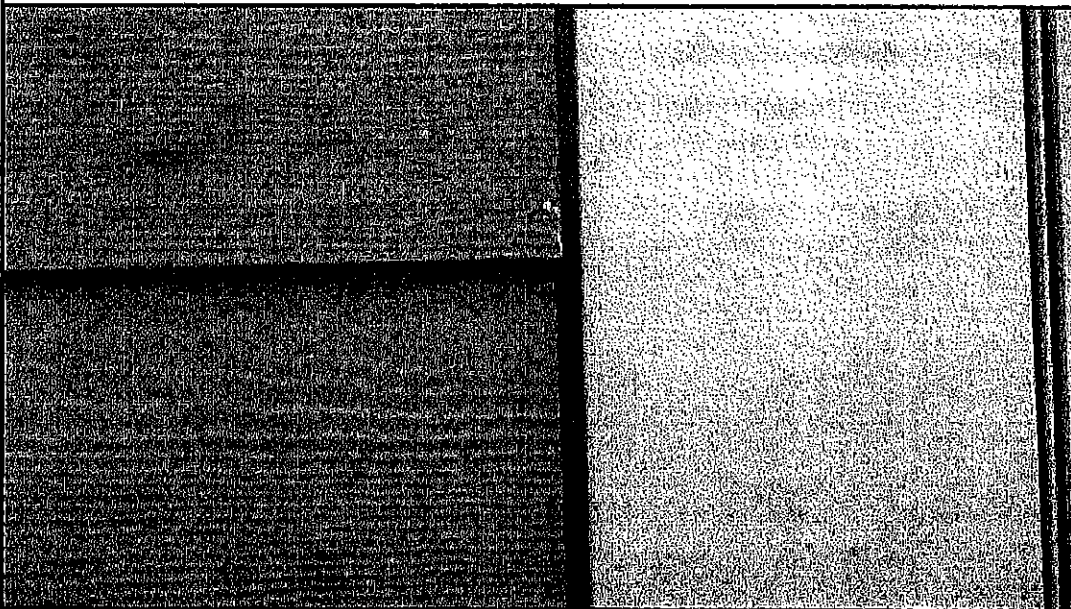
Photo No. 20

View of missing sealant at siding to trim transition, This condition will allow moisture behind the siding and trim.

Fiber Cement Siding - This material is operating correctly except for a few items that should be corrected. Most of the corrections can be handled with simple maintenance and sealing of open sealant joints. Attention to the window sill flashings is also recommended. Ensuring the water running off the metal window sill cannot roll back behind the siding and trim is important. Installing a different type of flashing may be required.

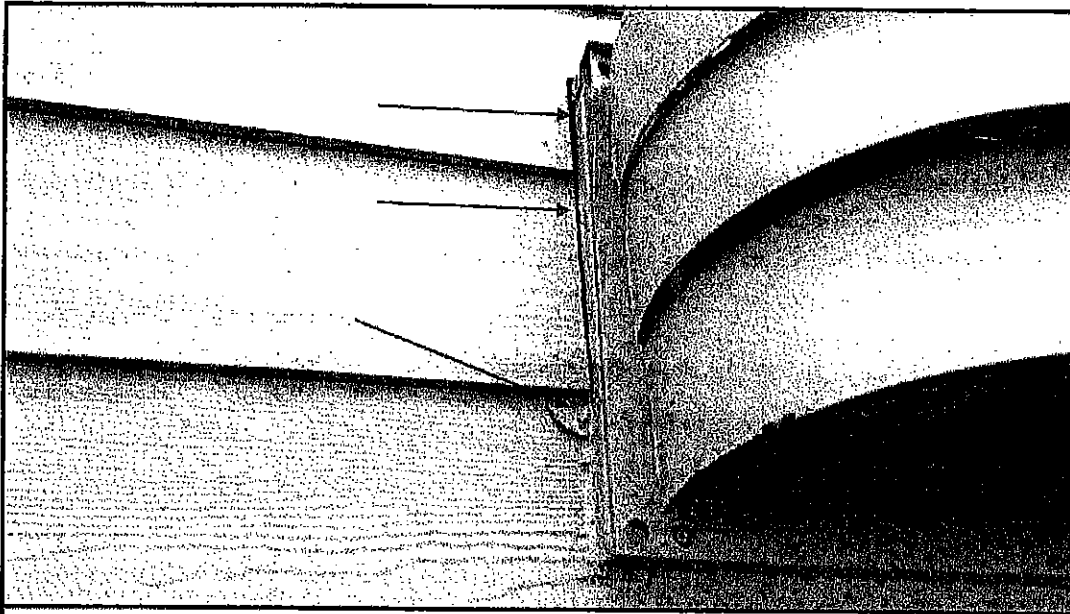
Photo No. 21

Missing sealant at the exhaust fan hood, Note sealant installed at the bottom
1/3rd causing water to be directed into the wall.

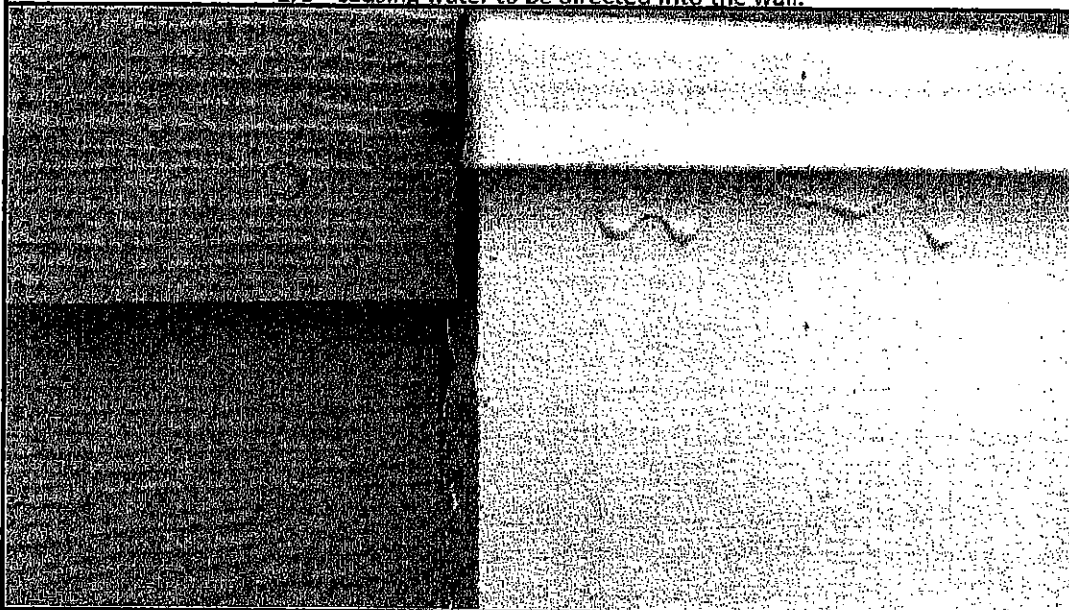
Photo No. 22

Close up view of failing sealant around the window trim, typical around the building.

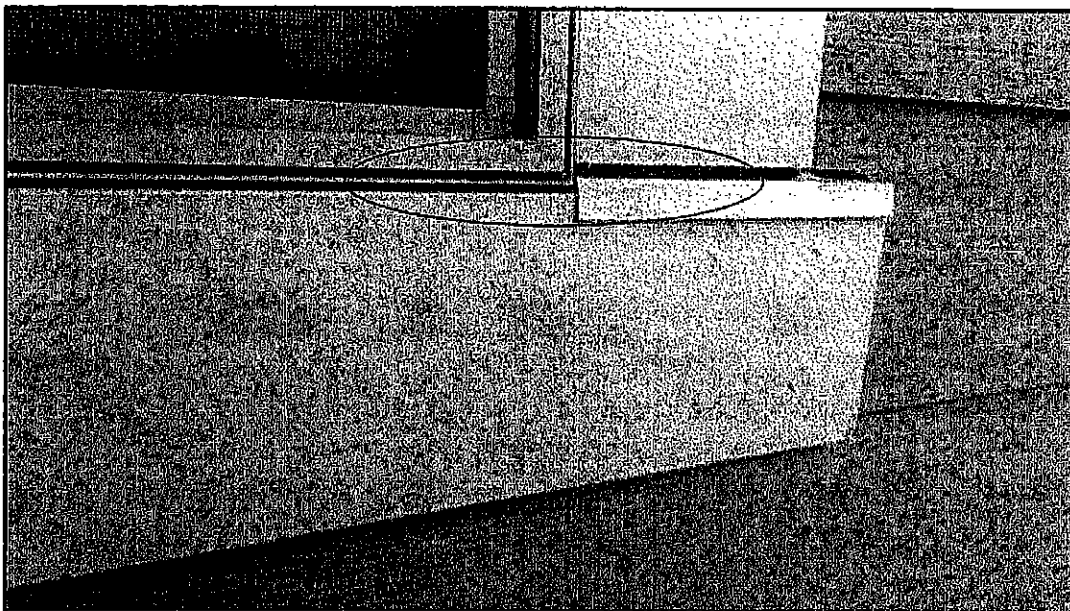
Photo No. 23

View of incomplete metal flashing and sealant application allowing water to enter behind the trim and into the wall system at window sill.

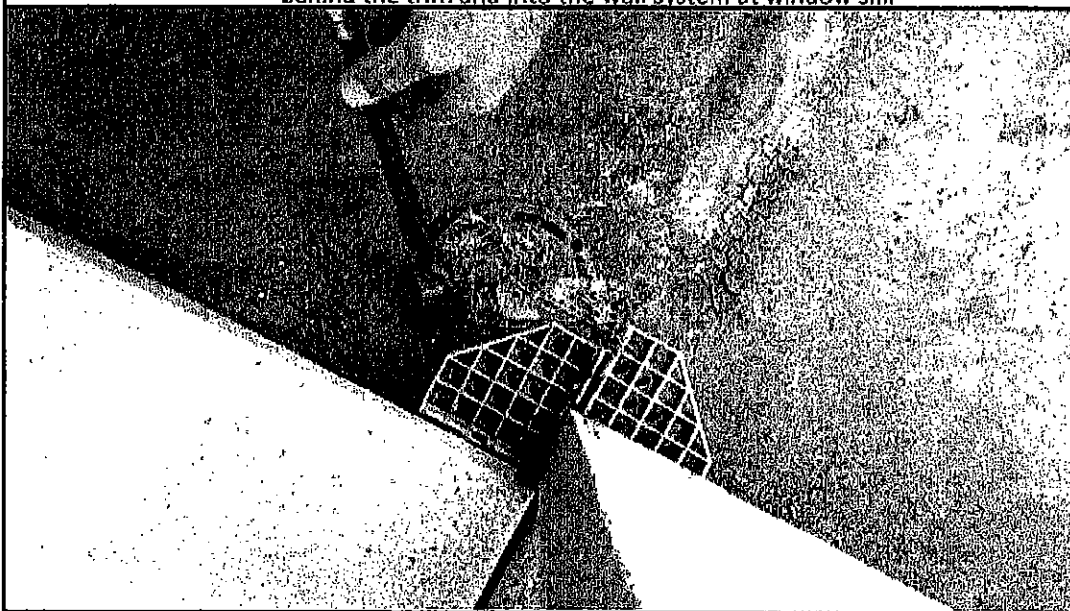
Photo No. 24

- a. PSI pulled several of the 2'x2'x2" concrete pavers in order to inspect the membrane and drainage, although the membrane appeared to be in good condition the installed drains were only 2 inches in diameter, of the 4 drains inspected 1 of the 4 had a drain strainer which was covered with debris.

View of EPDM membrane on balcony, showing debris over the drain strainer.

Balcony Decks - The installed drains on the balcony decks are too small for the surface area and do not provide adequate drainage, PSI recommend install a minimum of 4 inches diameter drains to create a generous water flow capacity for the rapid removal of collected water. A semi-annual maintenance program to clean these drains is recommended.
